RV Inspection Report

Parris RV, 4360 S State Street, Murray, UT 84107

Inspection Date / RV Model:
January 1, 2024 - 2024 Alliance Paradigm 310RL

RV Patch Mobile Repair

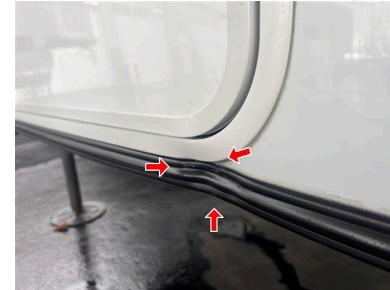
Front Wall Under Cargo Door View

Inspector observed a large dent in the Front Wall directly under the cargo door. It is recommended a qualified technician repair dent to help with proper function of cargo door.

Inspector observed a large dent in the Front Wall directly under the cargo door. It is recommended a qualified technician repair dent to help with proper function of cargo door.

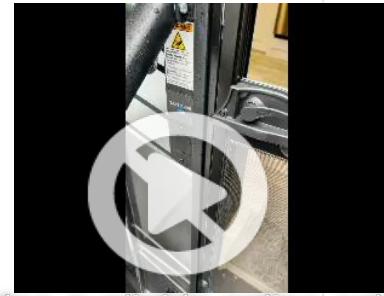
⚠ Inspector observed that the screen door doesn't latch when closing. Recommend a qualified technician repair screen door so it will stay closed.

Inspector observed that the screen door doesn't latch when closing. Recommend a qualified technician repair screen door so it will stay closed.

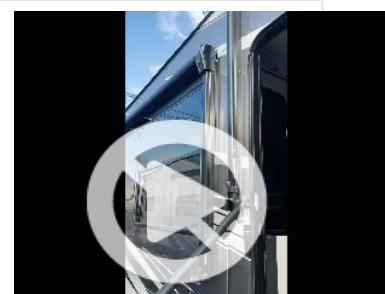
Curbside Rear Slideout
Operating Video

Inspector observed that the Curbside Rear Slideout sticks on the top when extending. It is recommended a qualified technician repair slideout to prevent future sticking or alignment issues.

Inspector observed that the Curbside Rear Slideout sticks on the top when extending. It is recommended a qualified technician repair slideout to prevent future sticking or alignment issues.

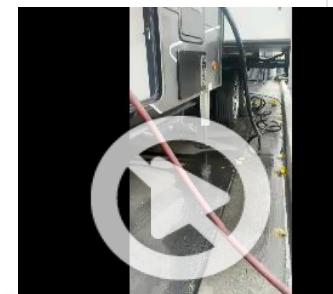
Leveling System Operating Video

☒ Inspector observed that the leveling system fluid reservoir is not filled to the minimum fill line. It is recommended a qualified technician fill reservoir with the proper fluid to ensure proper operation.

Inspector observed that the leveling system fluid reservoir is not filled to the minimum fill line. It is recommended a qualified technician fill reservoir with the proper fluid to ensure proper operation.

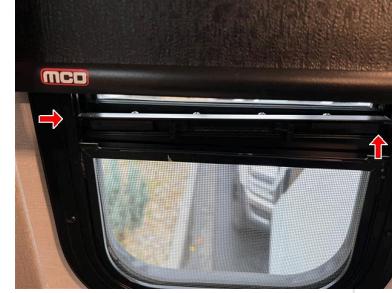
It was also observed that the Bedroom Slideout Front Window does not close properly. The right side sticks and is difficult to completely close. Recommend a qualified technician repair to correct window operation.

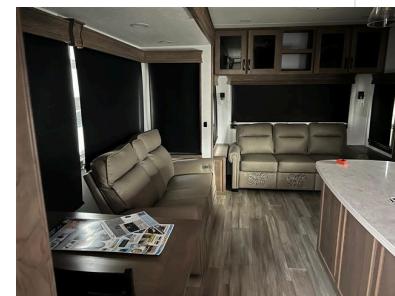
Kitchen / Living Blackout Shades

Inspector observed that none of the blackout shades sit flush against window frames, which allows light to come in from sides of shades.

Inspector observed that none of the blackout shades sit flush against window frames, which allows light to come in from sides of shades.
